Manhole Inspection Summary

Manhole # S41CC_046MH

Location Address: **900 n.eden**

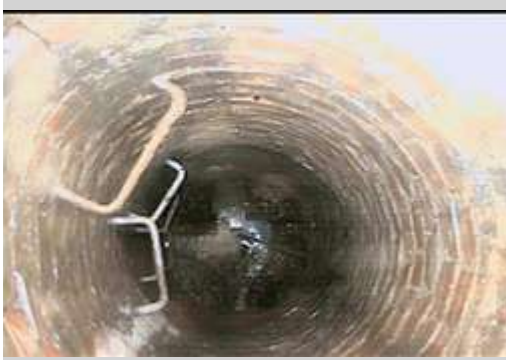
Defect 1

Condition: ☐ Sound ☐ Cracked ☐ Root Intrusion ☐ Deteriorated ☐ Leaks ☒ Debris

Count: **7** Missing: **0** ☒ Corroded

bench debris, corroded steps

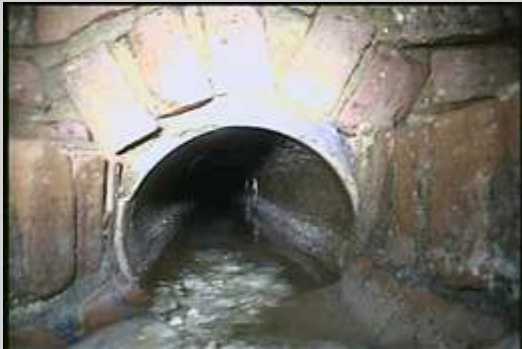
12 O'Clock Outflow

8 in. Circular Gravity Sewer
Pipe Out @ 12 O'Clock

Invert Depth: 14.00 (ft.) Flow Characteristics: **Slow**

Infiltration: **None** Pipe Seal Cond: **Unknown**

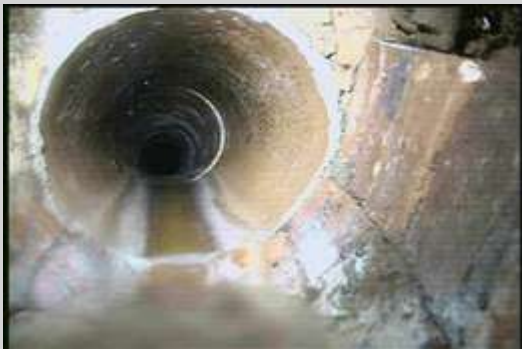
3 O'Clock Inflow

8 in. Circular Gravity Sewer
Pipe In @ 3 O'Clock

Invert Depth: 13.80 (ft.) Flow Characteristics: **Slow**

Infiltration: **None** Pipe Seal Cond: **Unknown**

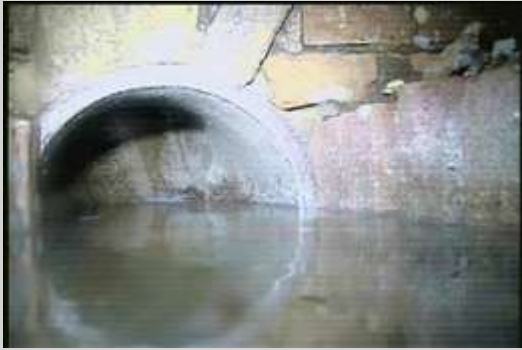
6 O'Clock Inflow

Invert Depth: **13.90** (ft.) Flow Characteristics: **Slow**

Infiltration: **None** Pipe Seal Cond: **Unknown**

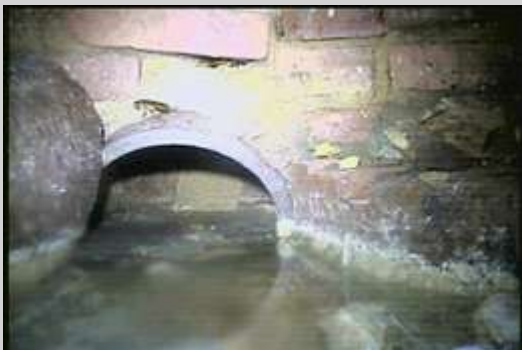
9 O'Clock Inflow

Invert Depth: **13.75** (ft.) Flow Characteristics: **Slow**

Infiltration: **None** Pipe Seal Cond: **Unknown**
